RESERVOIRS

The chapter on Masonry Dams has been increased twofold by an attempt to make some mention of all the most notable dams of the world, and many that are very little known. Attention is particularly directed to Plates 1, 2, and 3, in which profiles are shown of all of the leading and better known masonry dams in existence, drawn to uniform scale for easy graphical comparison. No such complete collection of dam profiles has ever before appeared in print, assembled together on a common basis.

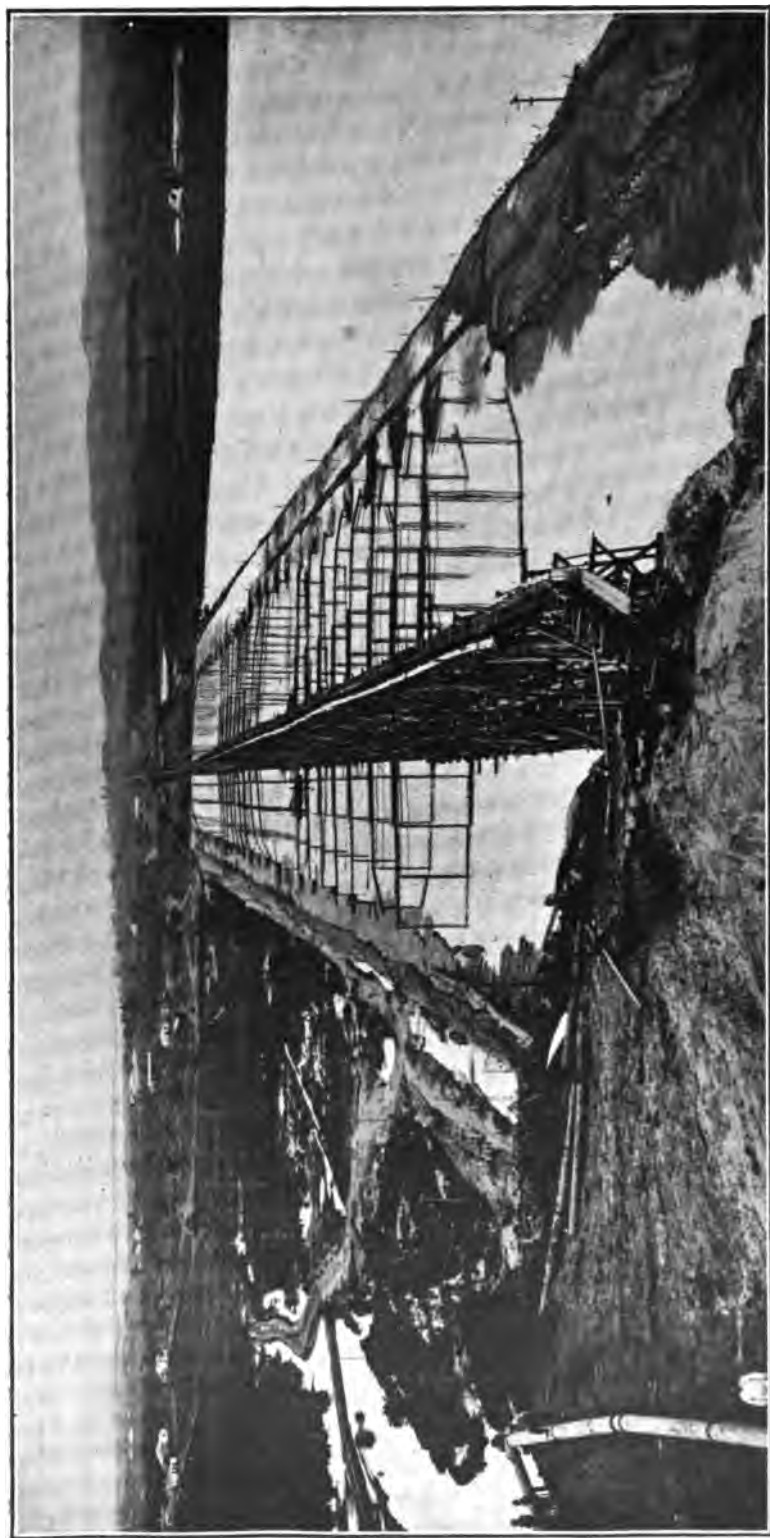
FIG. 108.—SANTO AMARO DAM, SAO PAULO, BRAZIL. (1 MILE LONG.) SHOWING METHOD OF DELIVERY OF SLUICED MATERIAL THROUGH FLUMES AND LATERALS.

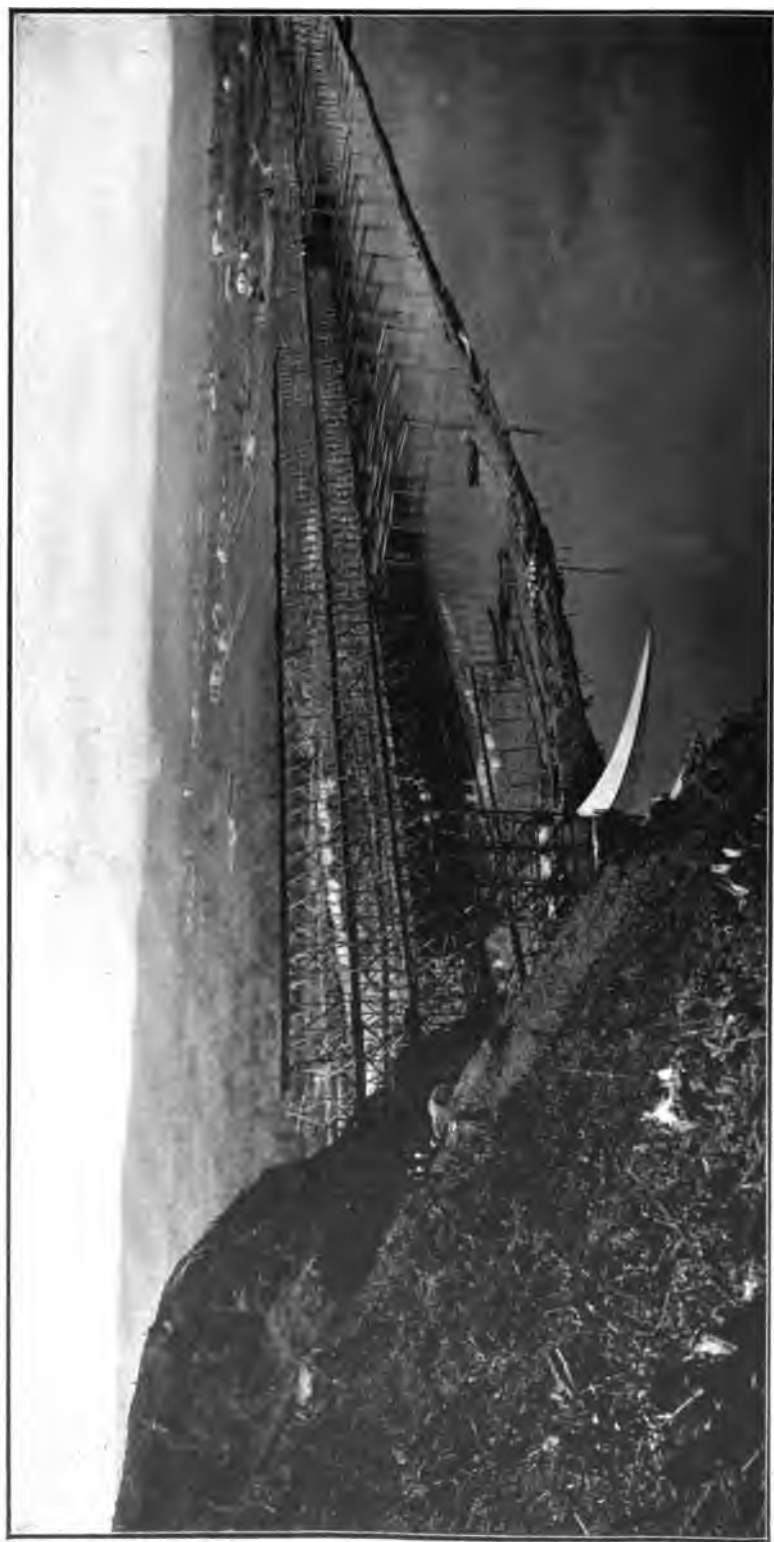
FIG. 109.—GENERAL VIEW OF SANTO AMARO DAM, BRAZIL, AUG. 21, 1907. SHOWING THREE LEVELS OF DELIVERY ON CENTRAL TRESTLE. TOTAL LENGTH 5300 FEET, MAXIMUM HEIGHT 63 FEET. 148

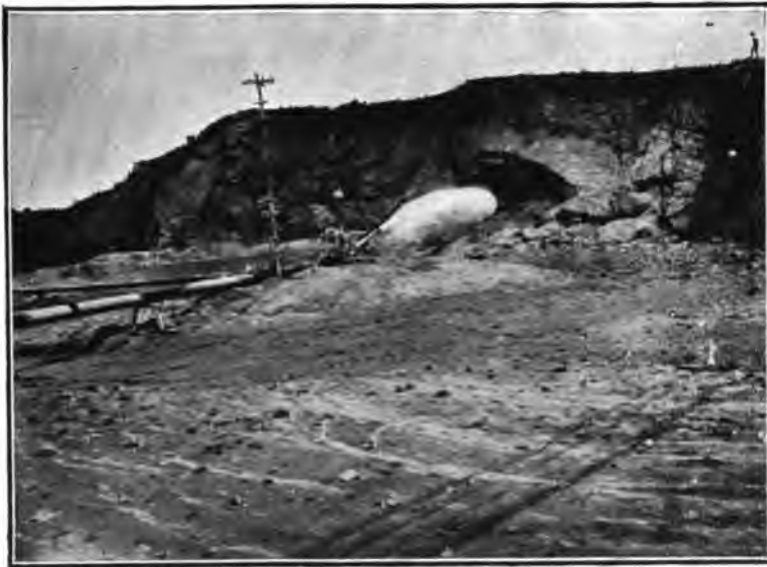
FIG. 110.—SANTO AMARO DAM, BRAZIL, SHOWING HYDRAULIC MONITOR AT WORK, DELIVERING 8 SECOND-FEET UNDER 85 POUNDS PRESSURE THROUGH 4-INCH NOZZLE.

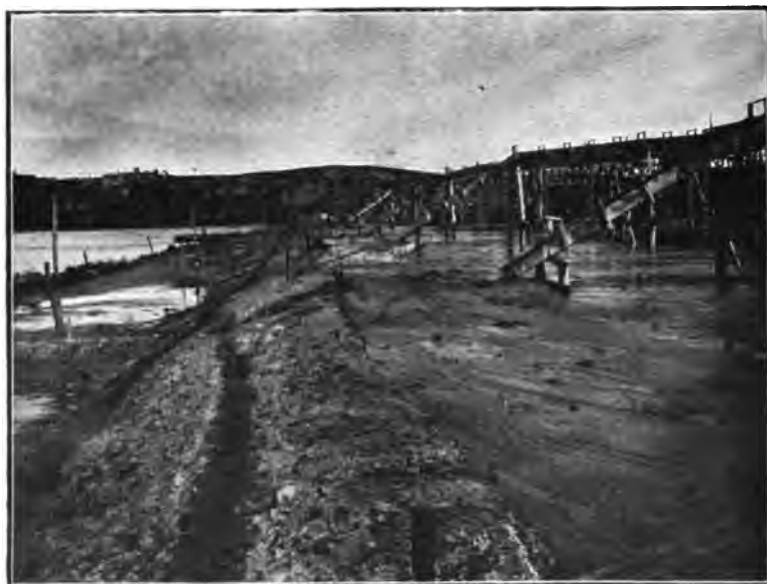
FIG. 111.—UPPER TOE FILLING ON THE SANTO AMARO HYDRAULIC-FILL DAM, BRAZIL, SHOWING LATERAL FLUMES.

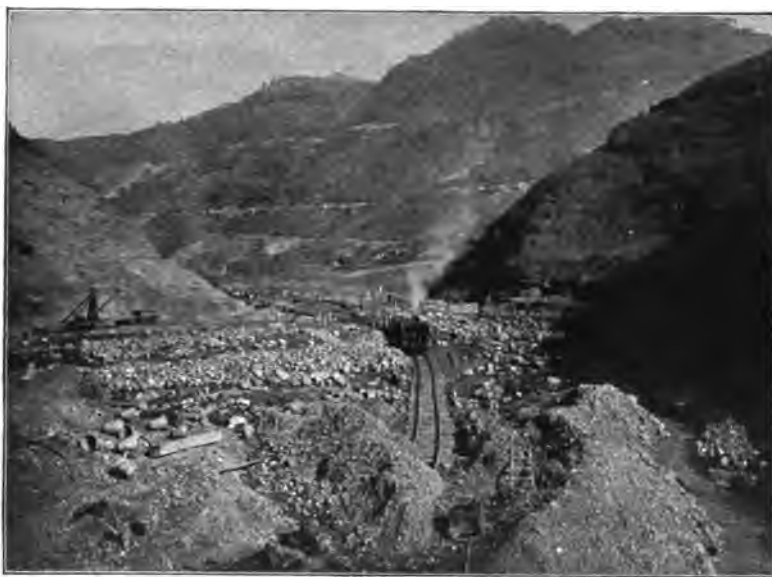
FIG. 114.—LOOKING UP STREAM AT SITE OF DAM NO. 2, AT NECAXA, SHOWING STRIPPED ABUTMENTS FOR THE DAM ON EACH SIDE.

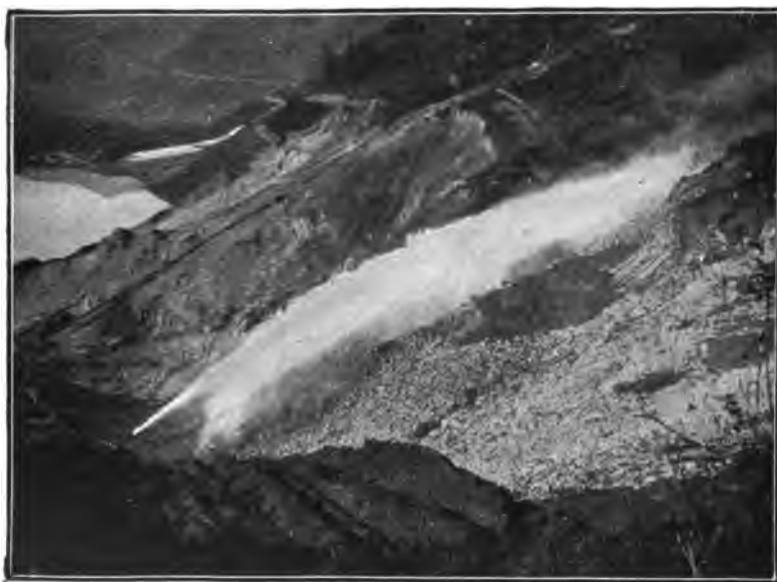
FIG. 115.—NECAXA DAM, MEXICO. HYDRAULIC MONITOR WORKING UNDER 180 POUNDS PRESSURE, 6-INCH NOZZLE, 30 SECOND-FEET OF WATER.

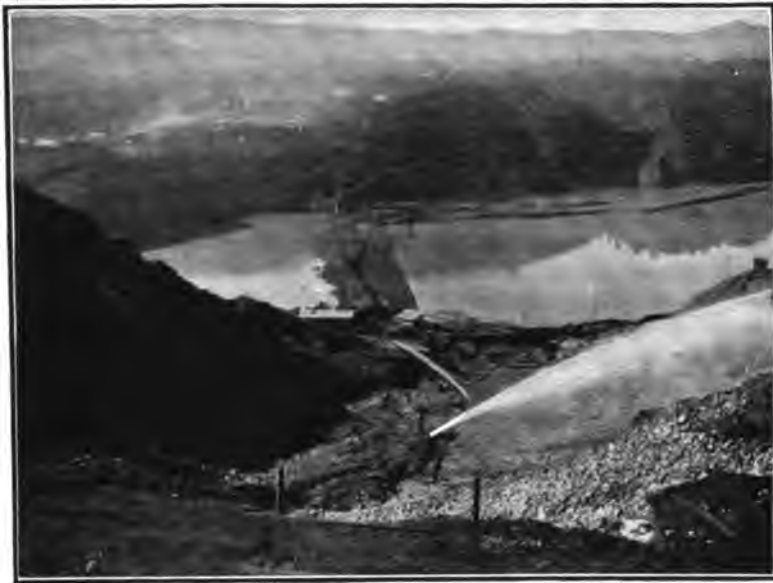
FIG. 116.—HYDRAULIC MONITOR IN ACTION, WITH 30 SECOND-FEET UNDER 180 POUNDS PRESSURE, 6-INCH NOZZLE. UP-STREAM TOE OF DAM SHOWN, WITH TAILING POND AT LEFT.

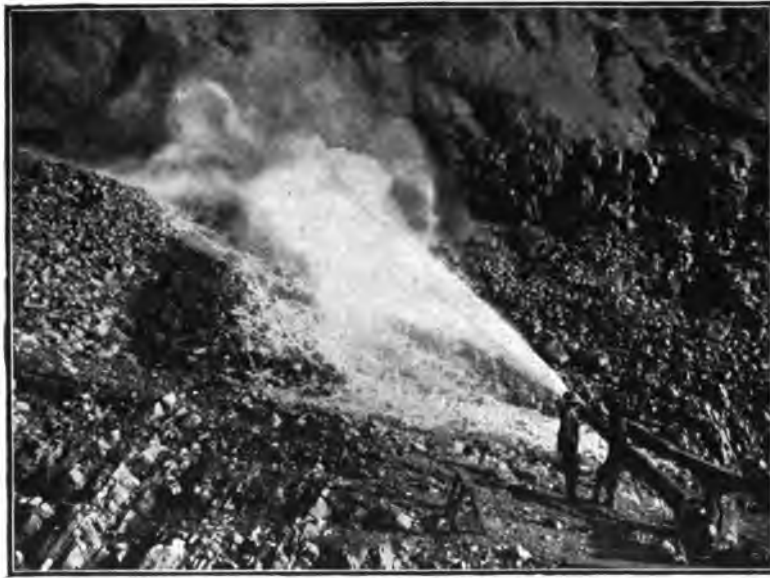
FIG. 117.—HYDRAULIC MONITOR WORKING ON LINE OF CONTACT BETWEEN LIMESTONE AND LAVA IN SPILLWAY CUT, NECAXA DAM, MEXICO.

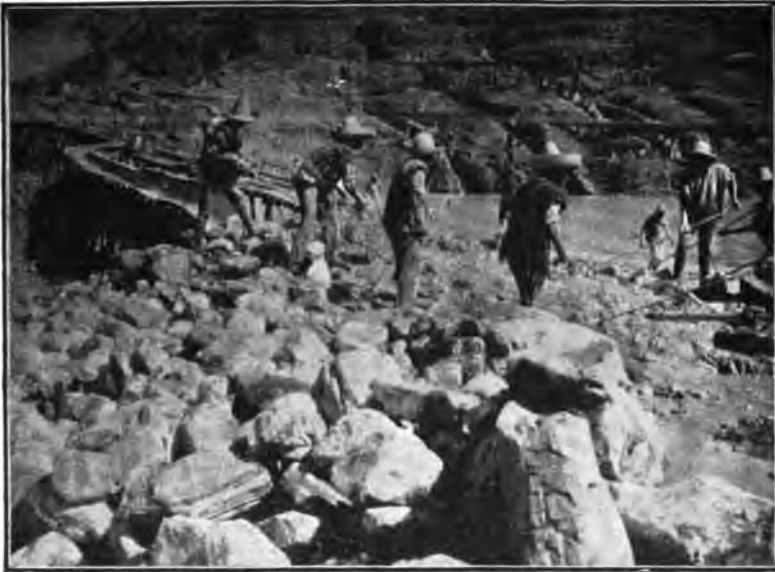
FIG. 118.—STONE CARRIED THROUGH FLUME TO UP-STREAM SLOPE OF THE NECAXA DAM.

of 60% to 70% mingled with stones of all sizes. The photographs, Figs. 118, 119, 120, 121, and 124 show the nature of the materials delivered to each and the manner of delivery.

A striking feature of this work, as illustrated by the photographs, Figs. 118 and 119, taken by the author in January, 1908, is the large size of rocks which have been transported through the flumes and deposited on the dam. Many of these contain upwards of 15 cubic feet and weigh over 1 ton. In this respect the magnitude of the operation exceeds any hydraulic sluicing ever before attempted. The down-stream slope is being covered with 2 feet of masonry laid in Portland cement, using

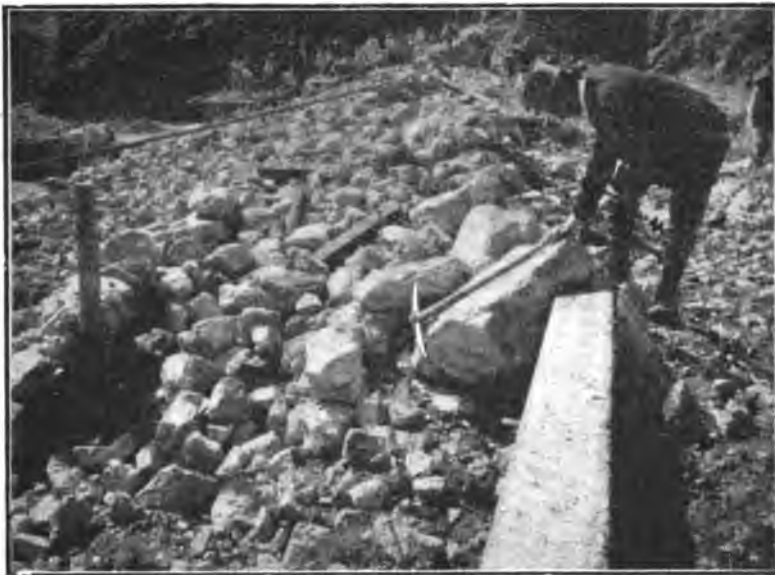
FIG. 119.—ILLUSTRATING THE SIZE OF STONE DELIVERED BY FLUME TO THE NECAXA DAM. THE LARGEST ONE MEASURED CONTAINED 18 CUBIC FEET.

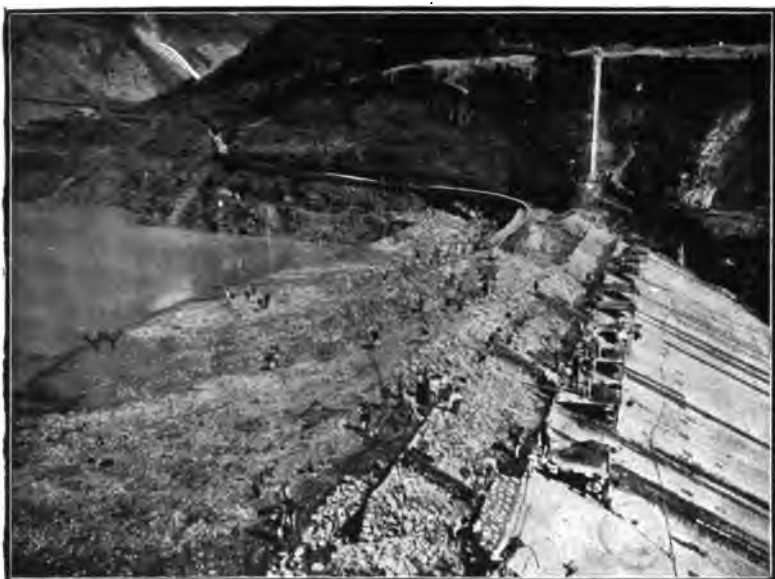
FIG. 120.—LOWER TOE OF NECAXA DAM, LOOKING NORTH, SHOWING DELIVERY OF ROCK AND CLAY BY FLUME.

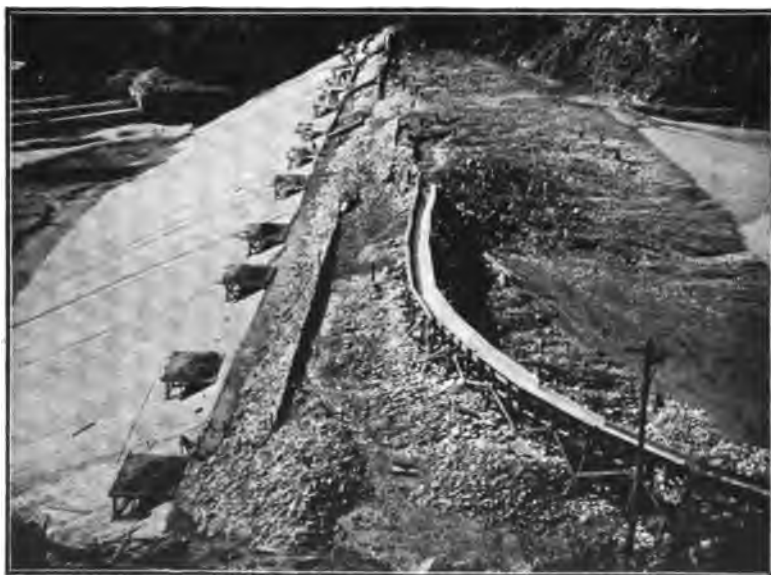
FIG. 121.—DOWN-STREAM SLOPE OF NECAXA DAM, SHOWING MASONRY PAVEMENT ON FACE AND CHARACTER OF SLUICED MATERIAL.

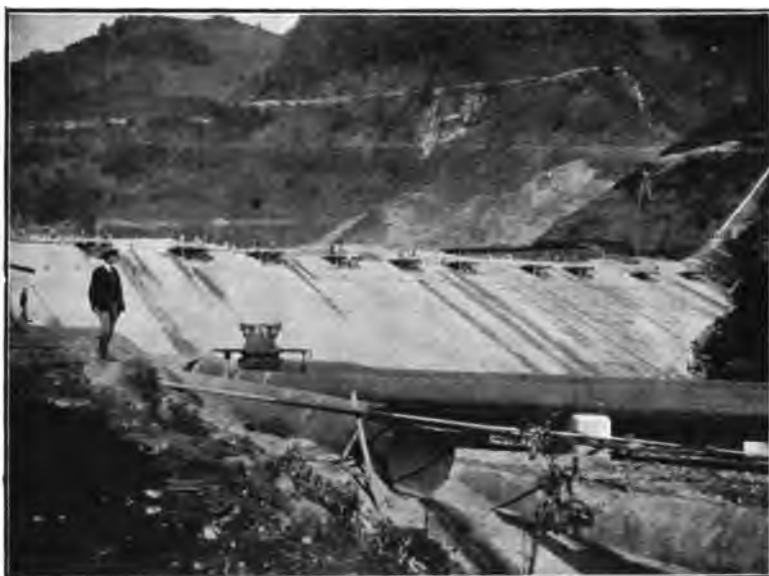
FIG. 122.—NECAXA DAM FROM BELOW, AT HEIGHT OF 85 FEET. JANUARY 1, 1908.

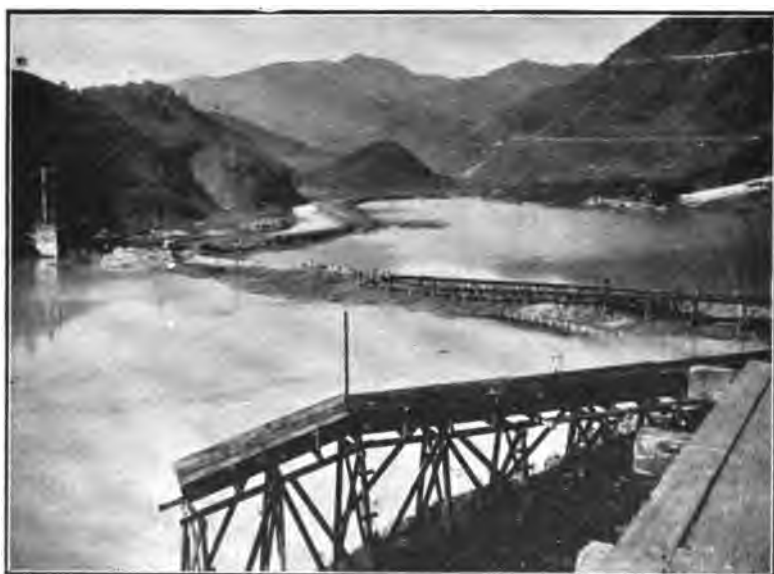
FIG. 123.—NECAXA DAM AND RESERVOIR. SLUICE DITCH IN UPPER RIGHT-HAND CORNER OF PICTURE.

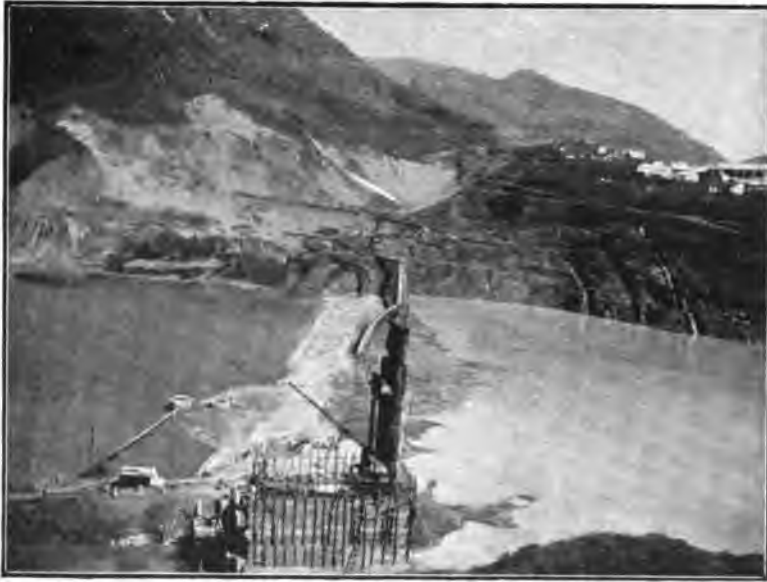
FIG. 124.—NECAXA DAM, UP-STREAM SLOPE, LOOKING TOWARD SLUICING PIT AND SPILLWAY GAP.

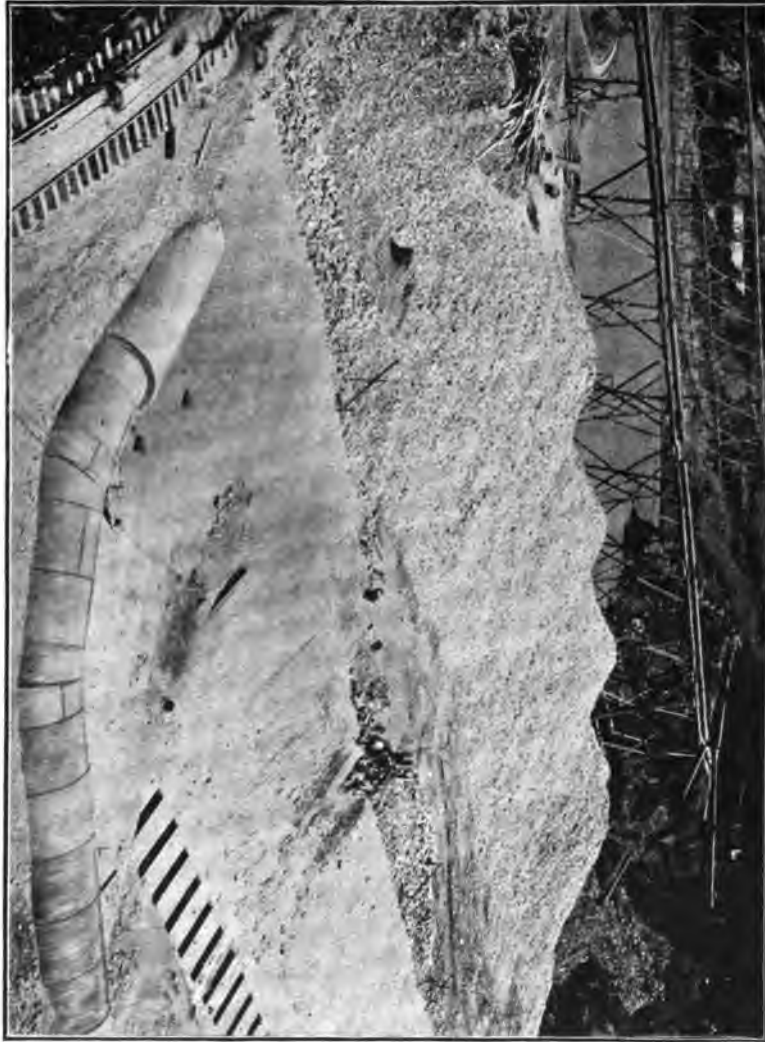
FIG. 126.—LOWER TOE OF NECAHA DAM, MEXICO, SHOWING CHARACTER OF HYDRAULIC-FILL MATERIAL. PIPE IN FOREGROUND IS 10 FEET IN DIAMETER, USED ONLY FOR FLOOD DISCHARGE DURING CONSTRUCTION.

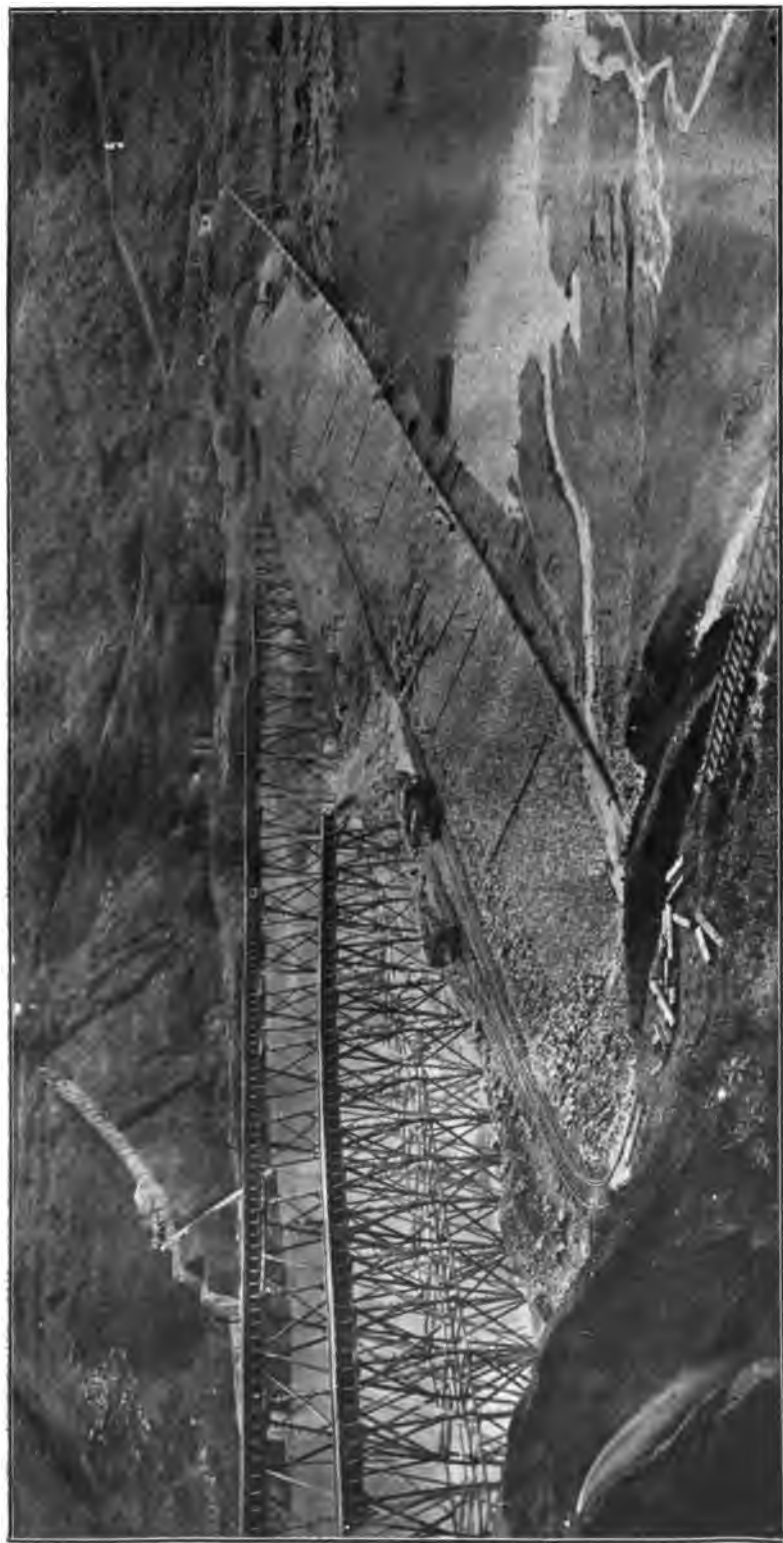
FIG. 128.—NECAXA DAM, MEXICO, OCT. 26, 1907, SHOWING MATERIAL BEING DEPOSITED BY FLUME. ALSO HYDRAULIC ELEVATOR OPERATING UNDER 700 FEET HEAD, LIFTING WATER FROM POND INTO POWER CANAL AT HEADWORKS AT END OF PIPE.

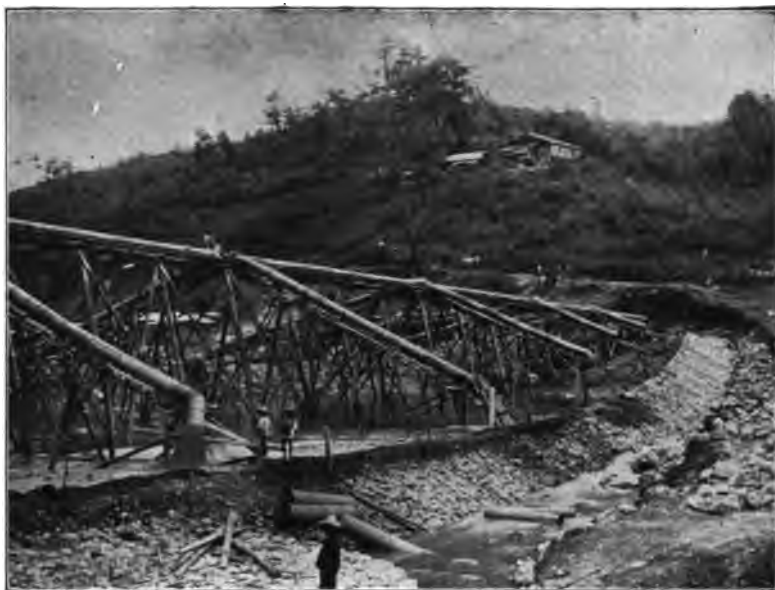
FIG. 130.—LIQUID EARTH BEING DEPOSITED THROUGH PIPES ON OUTER SLOPES OF DAM NO. 1, TENANGO RIVER.

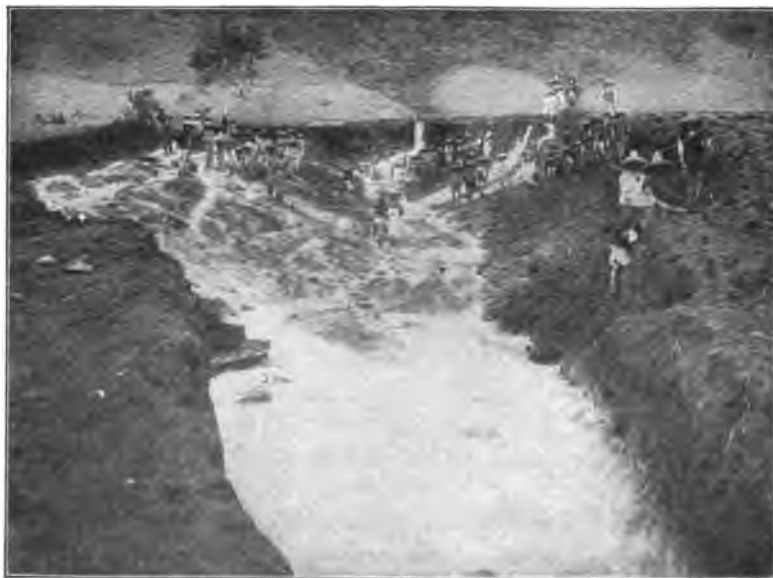
FIG. 131.—GROUND-SLUCING ON DAM NO. 1, TENANGO RIVER.

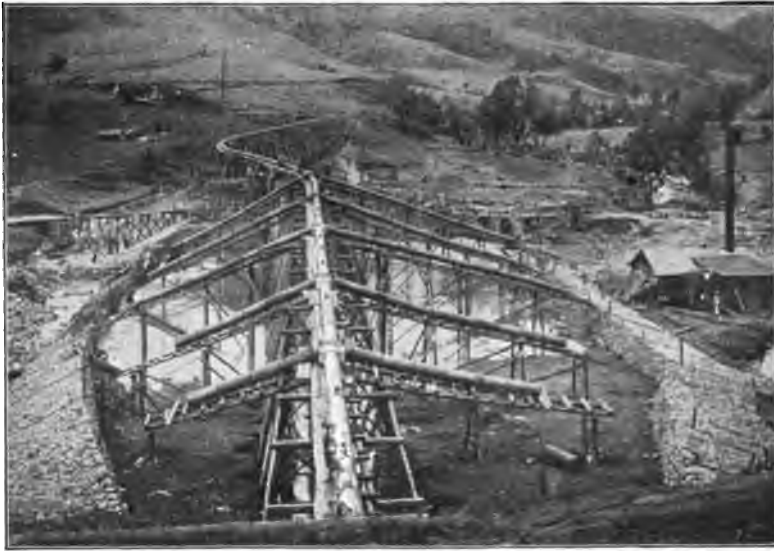
FIG. 132.—METHOD OF DISTRIBUTING SLUICED MATERIALS THROUGH PIPES, DAM No. 1, AT ACATLAN, TENANGO RIVER.

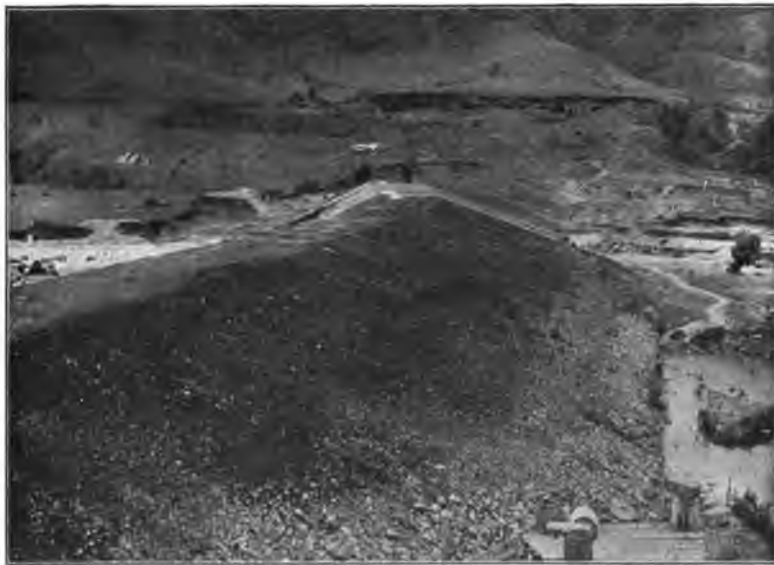
FIG. 133.—DAM No. 1, AT ACATLAN, TENANGO RIVER, COMPLETED JULY, 1906. THE MATERIALS FOR THE DAM WERE GROUND-SLUICED FROM THE BORROW-PITS IN THE BACKGROUND.

Dam No. 1, at Acatlan.—This structure was completed in June, 1906. It serves as a diverting weir to turn the water of the Tenango River to the Necaxa, through a 3000 foot tunnel. Its extreme height is about 30 feet and it was built of earth by the ground-sluice method, with water taken from the stream through a short ditch. Figs. 130, 131, and 132 illustrate the construction of the dam, and Fig. 133 shows the finished dam viewed from the tunnel portal. It is divided into two sections by a concrete weir located in the stream channel at the deepest portion. When examined with an earth auger to a depth of 20 feet below the crest six months after completion the core material was found in a plastic but compact condition. The dam has shown no sign of leakage or seepage and but very slight settlement.

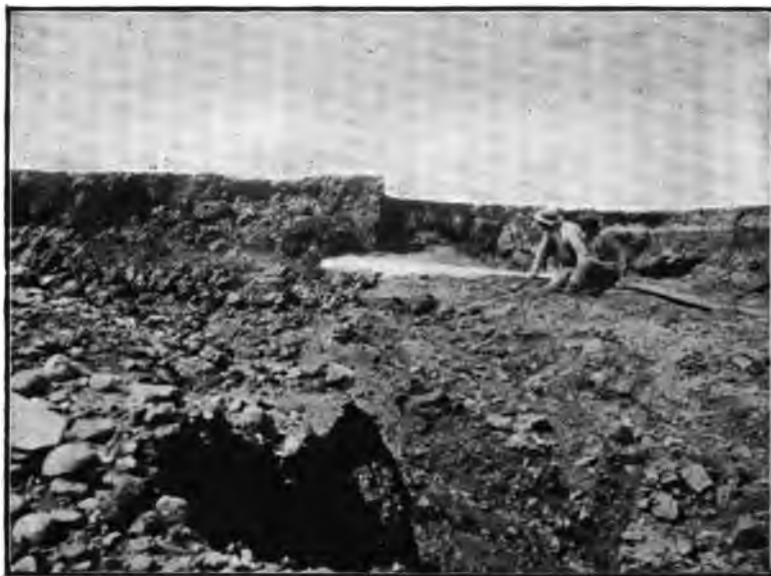
FIG. 134.—YORBA DAM, CALIFORNIA. HYDRAULICKING AN EARTH BANK WITH WATER PUMPED THROUGH 1-INCH NOZZLE UNDER 25 POUNDS PRESSURE.

Fig. 134 shows the operation of hydraulic sluicing, and Fig. 135 illustrates the method of delivery of earth upon the dam. The surplus water was drained from the pond through stand-pipes built up in successive layers and connecting with the main outlet-pipe through which the water was fed into the reservoir. The entire cost of the dam was about \$38,000.

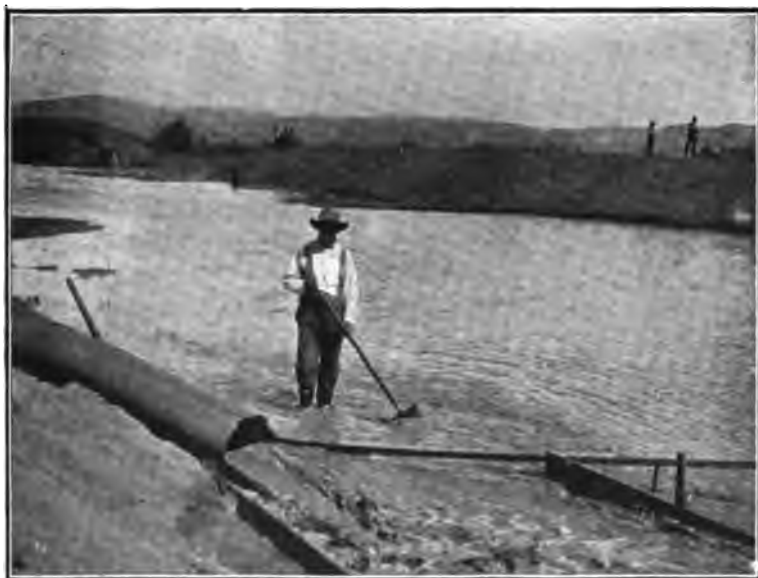
FIG. 135.—YORBA DAM, CALIFORNIA. SHOWING DISCHARGE OF PUMPED MATERIAL, ALONG UP-STREAM TOE LEVEE.

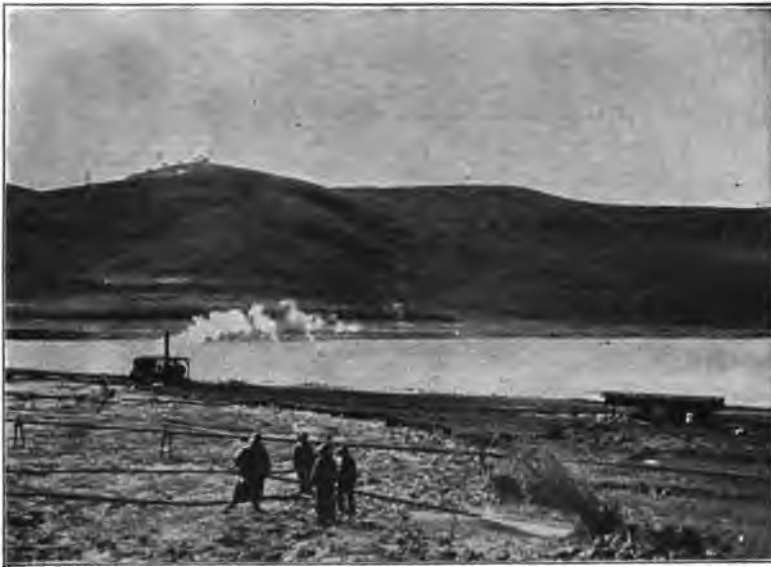
FIG. 136.—SILVER LAKE DAM, LOS ANGELES. THE EARTH, LOOSENED BY THE HYDRAULIC JET, IS CONVEYED TO THE PUMPING STATION SHOWN AND PUMPED TO THE DAM.

At the lower levels the material used to build the dam was loosened and dissolved by ground sluicing with water taken from a grade-line pipe passing through the reservoir. The liquefied earth flowed by gravity down the slope to a sump whence a centrifugal pump forced it through a pipe to the dam, where it was distributed by flumes and lateral branch pipes. At a later stage the hydraulic jet was used for loosening the earth, the water being pumped by a single-stage centrifugal pump through 4-inch pipe, and delivered under pressure of 70 to 100 pounds through 2-inch nozzles, controlled by a local modification of the more expensive hydraulic monitor used in the mines.

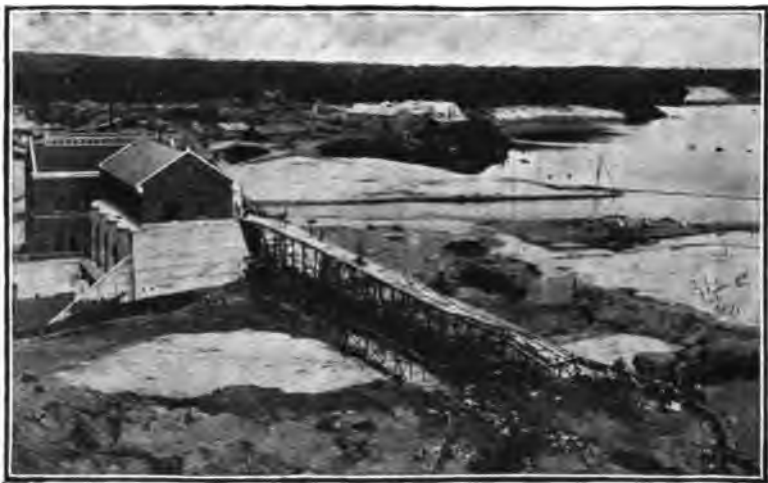
FIG. 137.—CROTON HYDRAULIC-FILL DAM, MICHIGAN, DURING CONSTRUCTION.

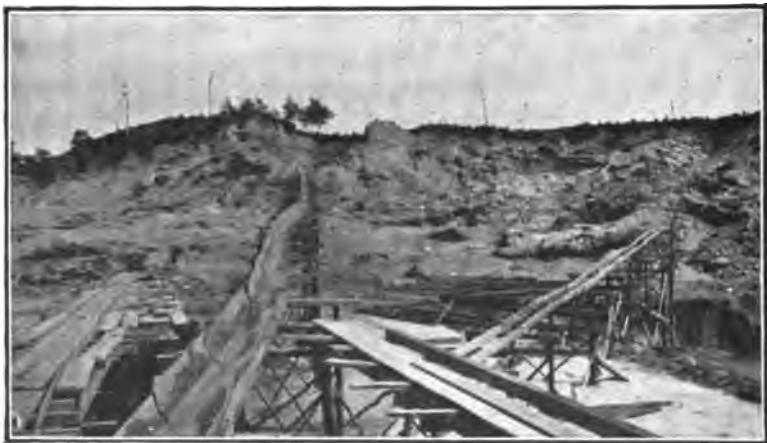
FIG. 138.—CROTON DAM, MICHIGAN, ILLUSTRATING FLUMES AND TRESTLE SUPPORTS USED IN HYDRAULIC SLUICING.

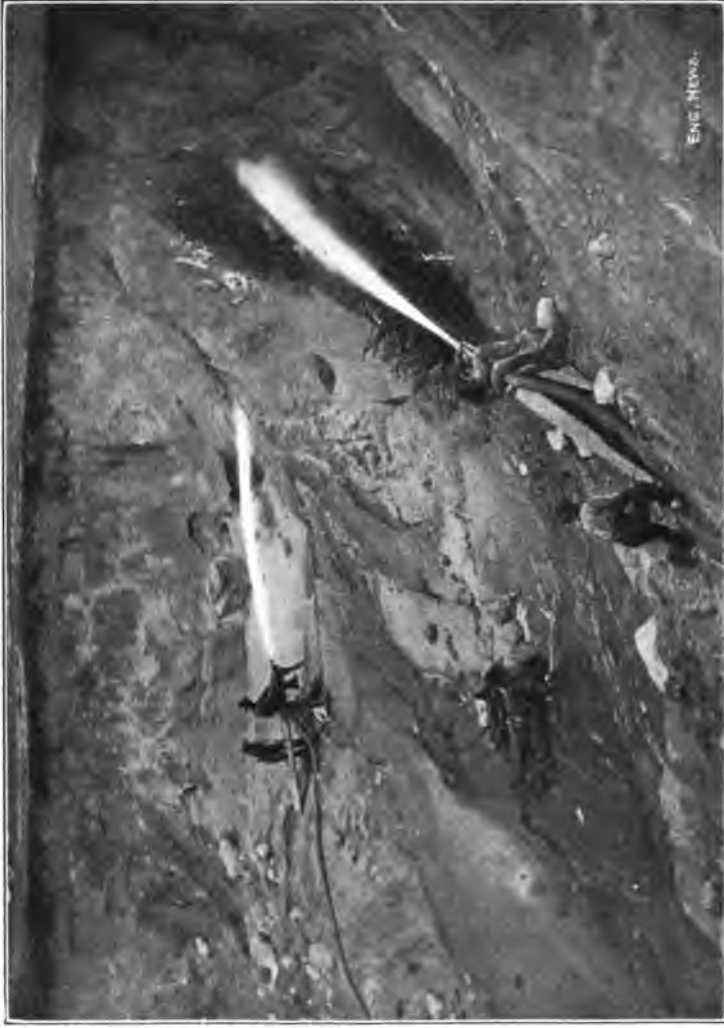
FIG. 139.—HYDRAULIC SLUICING ON THE CROTON DAM, SHOWING THE IMPROVED NOZZLE CONTROL,
OR HYDRAULIC MONITOR. 181

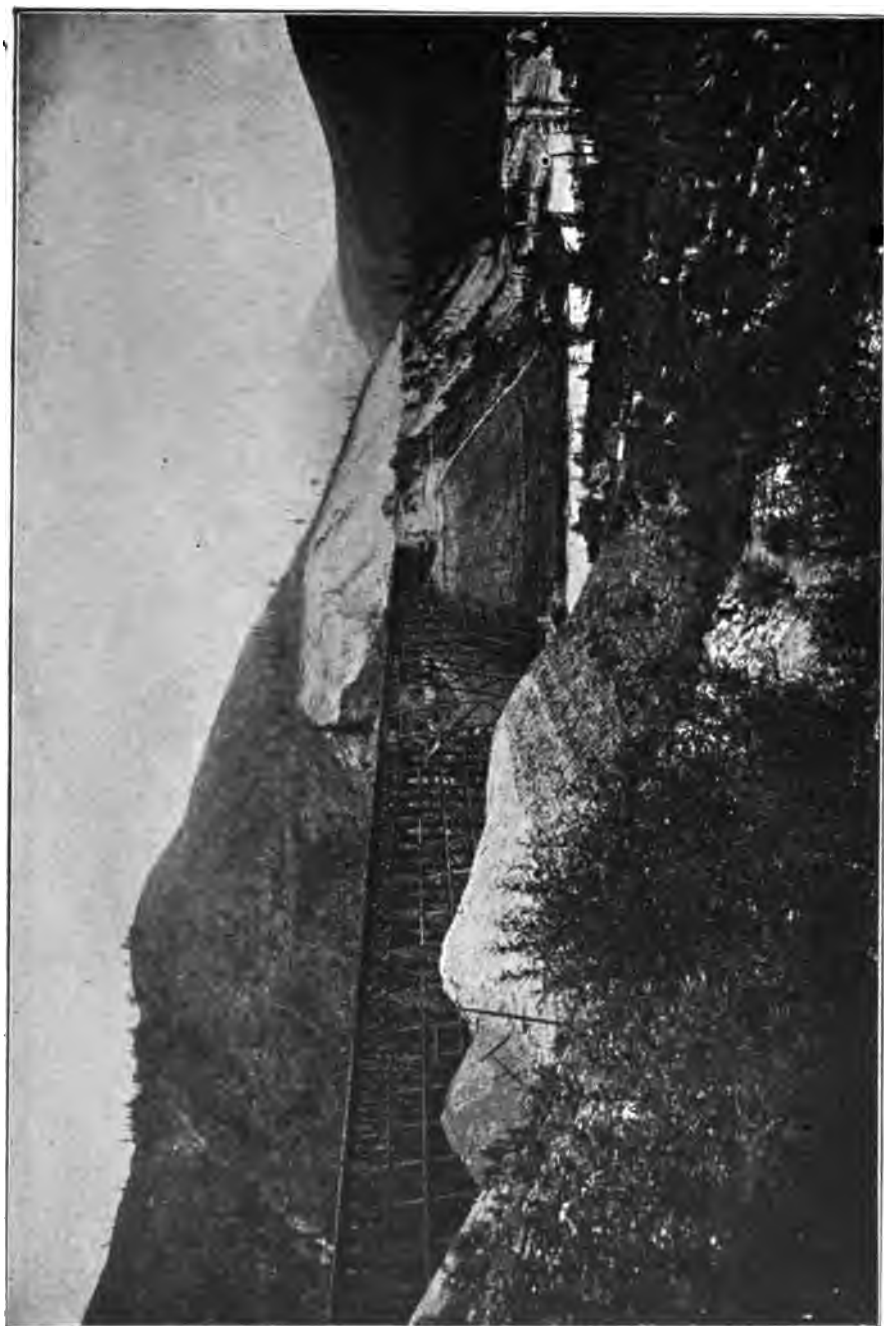
FIG. 141.—HYDRAULIC FILLS, PARTIALLY COMPLETED, AT MOUNTAIN CREEK, B. C., CANADIAN PACIFIC RAILWAY.

In 1897-98 the same company made a similar fill at the crossing of Mountain Creek, in the Selkirk Mountains, requiring 400,000 cubic yards. (See Fig. 141.) The total length was 10,086 feet over all, with extreme depth of 154 feet. The fill was carried up on a slope of $1\frac{1}{2}$ to 1. Between Aug. 10 and Nov. 1, 1897, over 65,000 cubic yards were sluiced in place, at the following cost:

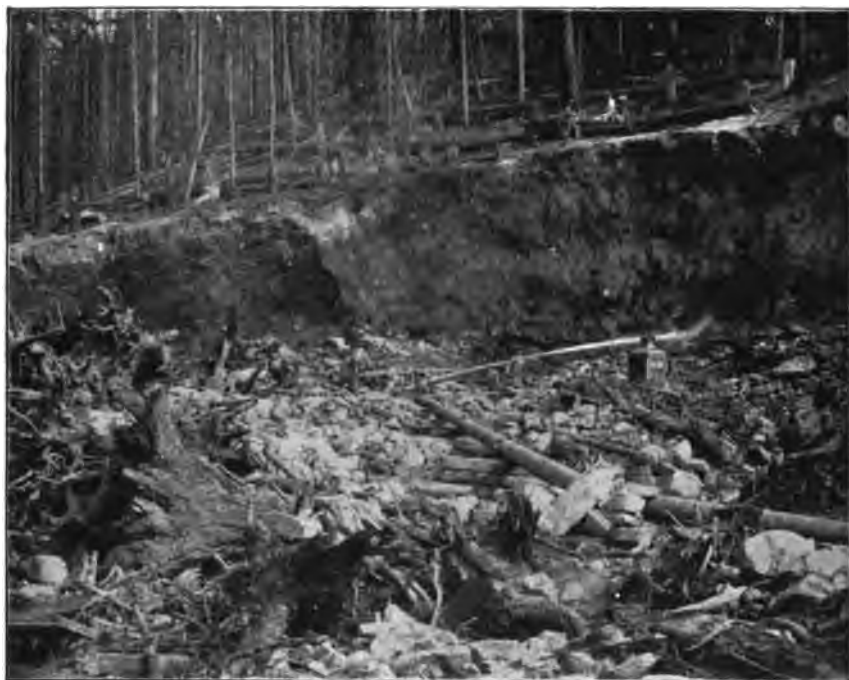
FIG. 145.—NORTHERN PACIFIC RAILWAY, HYDRAULIC-FILL CONSTRUCTION. VIEW IN PIT SHOWING HYDRAULIC GIANT IN ACTION.

"The plant required for the work is rather inexpensive. According to locality, one nozzle would require from 300 to 1000 feet of light sheet-iron

pipe, costing about 27.5 cents per foot, and a No. 2 Giant, costing \$95. Outside of this nothing is required except picks, shovels, hoes, and axes.

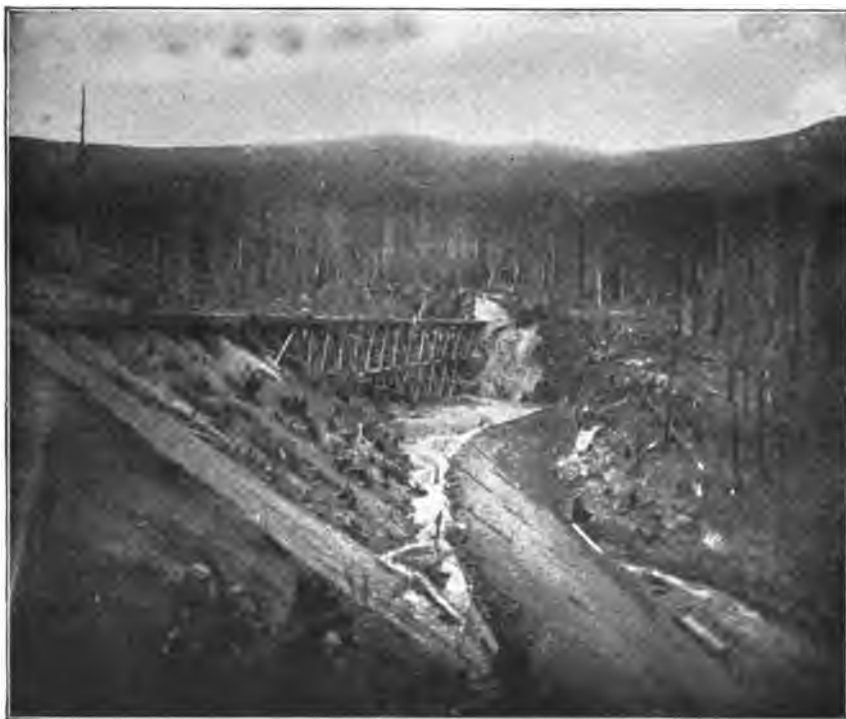
FIG. 146.—NORTHERN PACIFIC RAILWAY, BRIDGE 184. HYDRAULIC FILLING IN PROGRESS.

The distinctive advantage recognized in favor of hydraulic filling of trestles on railways is that it can be carried on without interruption to the traffic and without endangering the trestle, either by falling rocks or unequal settlement, and when it is completed no further settlement of the embankment can occur. The latter advantage applies with special force to dam-construction, and is one whose importance can scarcely be overestimated. Where the materials available consist of large and small stones, either angular or rounded with small gravel, sand, and silt, the ease with which these materials may be graded and assorted so as to permit the outer portion of the embankment to be built of the coarser rock where it will afford ready drainage, while the finer particles may be assembled in the center and inside where they will best resist percolation, constitutes a further advantage, which may well be considered as an efficient substitute for the ordinary puddle-wall of earth dams built in the usual manner.

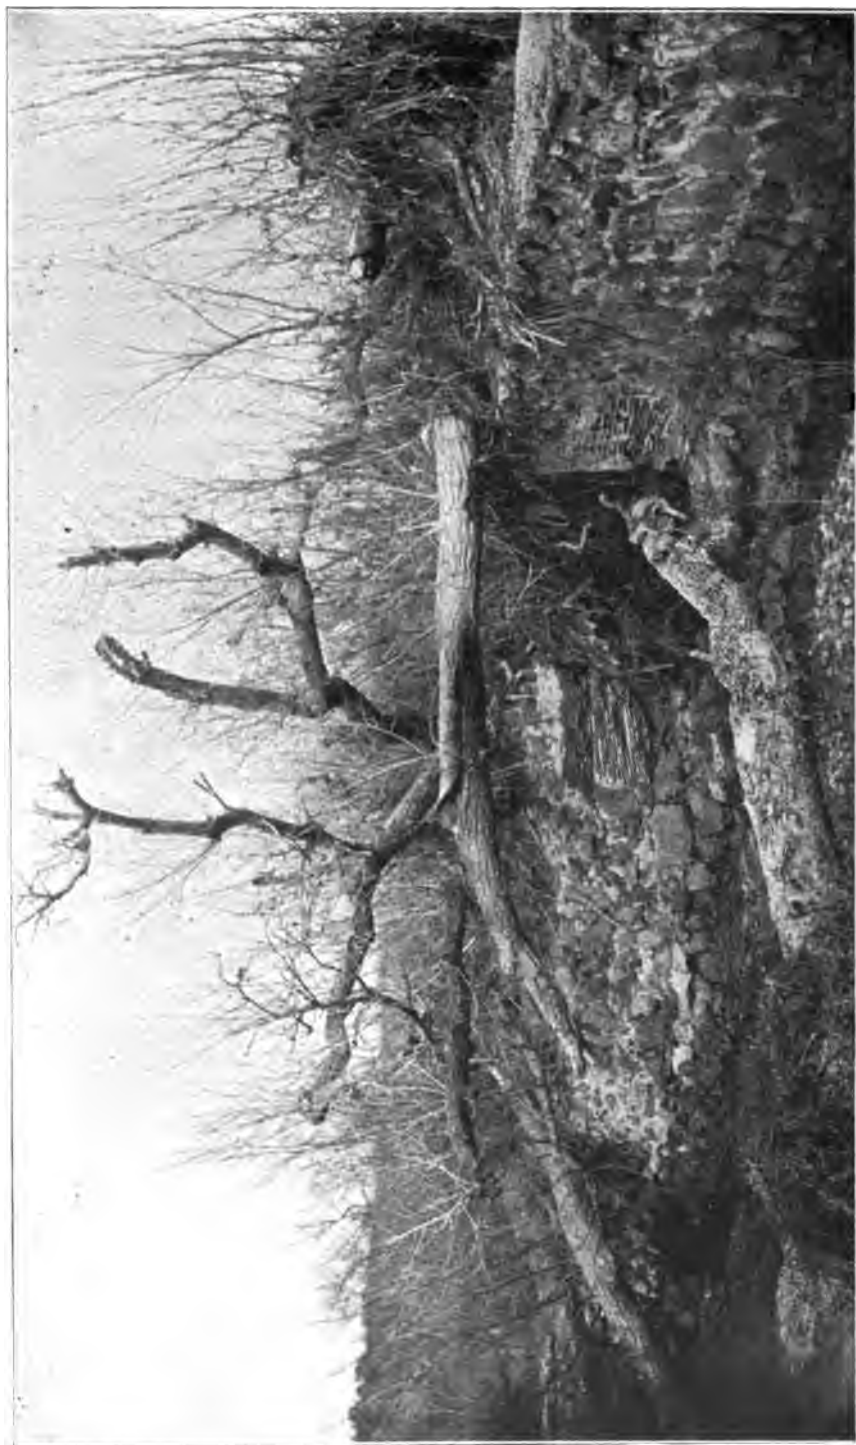
FIG. 149.—OLD MISSION DAM, NEAR SAN DIEGO, CAL. THE FIRST IRRIGATION DAM BUILT IN THE UNITED STATES.

Old Mission Dam, San Diego, Cal.—The first masonry dam built in California of which there is any record was erected in 1770 by the Jesuit Mission Fathers. It was constructed across the San Diego River, 13 miles above its mouth, at the lower end of El Cajon Valley, where the stream cuts through a dike of porphyry. It was built for impounding and diverting water for irrigation and domestic use at the San Diego mission 4 miles below. It was 244 feet in length, 13 feet in thickness, and about 15 to 18 feet high. Fig. 149 is a recent photograph of the old dam in its present condition, half buried in trees and driftwood. The view is taken below the main outlet-sluice. The water was conveyed to the mission through an open masonry conduit, lined with semicircular tile or half-pipes. The cement used in the dam was made from limestone possessing hydraulic properties, quarried near the dam. The dam, though still in existence, has been disused for half a century past. It shows evidence of having been damaged by floods and repaired at various times. The manual labor of construction was done by Indians, of whom no less than 1600 neophytes were at one time supported at the mission. Considering the quality of the materials and labor available, and the torrential nature of the river, which it has resisted, as evidenced in the photograph by the driftwood piled up against it, the masonry is of excellent grade.

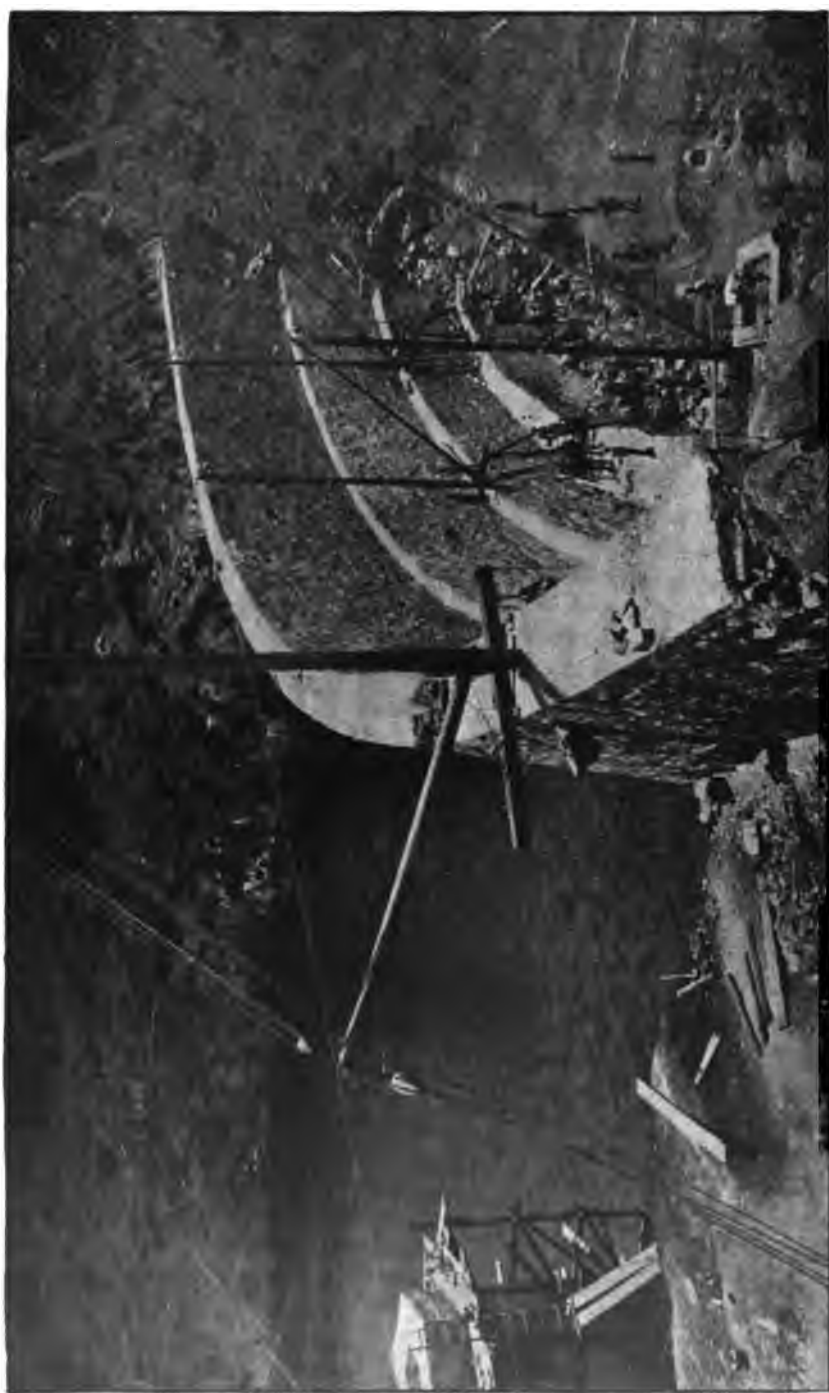
FIG. 150.—ORIGINAL SWEETWATER DAM AS COMPLETED TO THE SIXTY-FOOT CONTOUR.

As originally designed, the dam was to be a slender masonry or concrete structure, fashioned after the Bear Valley dam by the same engineer who built the latter, and was to be but 10 feet thick at base, 3 feet at top, and 50 feet high, backed on the water-face by an embankment of quicksand. When the wall had reached a height of 15 to 20 feet at the highest part, at an expenditure of \$35,000, and its outline and design were fully realized by the management, the plan was disapproved and the author was engaged to construct a more substantial work on the same site, utilizing the masonry already in place. The new plan was drawn to have an extreme height of 60 feet, and the new work enveloped the old. This structure is shown nearly complete in Fig. 150, and its profile is shown in dotted lines in the middle section on Fig. 151. It was built in steps on the back with a view to adding to its height, as was subsequently done. The dam had a maximum thickness of 35 feet at

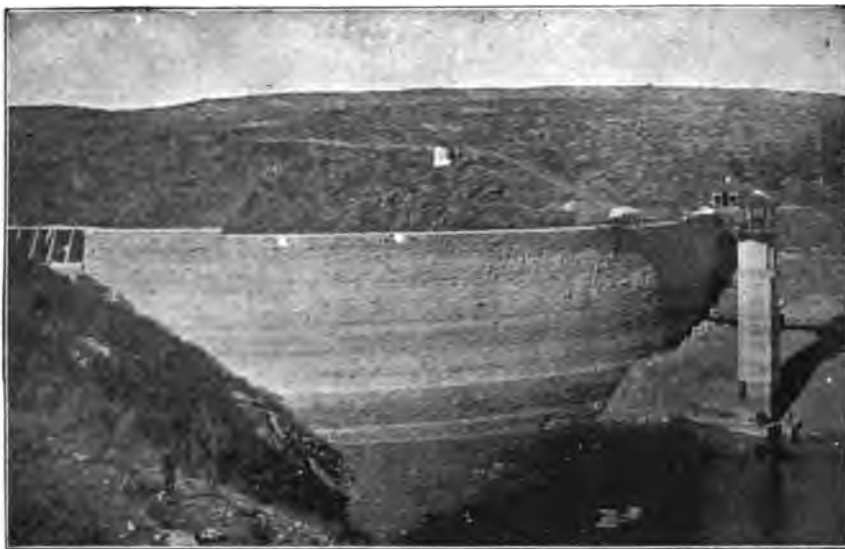
FIG. 152.—FACE OF SWEETWATER DAM IN 1899. AFTER TWO YEARS OF DROUTH.

base, and was 5 feet thick at the top. It was fortified by an embankment of clay and gravel 50 feet wide, 10 to 15 feet high, placed against the upper side and well tamped in place. A portion of this embank-

ment above the water-line is shown in Fig. 152, a view taken in the summer of 1899 when the reservoir was practically empty.
